Cases by Bosch Diesel Specialist with the JLM Diesel Particulate Filter Cleaner

The following data & case results were compiled by a Bosch Diesel Specialist in the United Kingdom. In these case reports we briefly describe 4 cases of modern diesel cars that came into their workshop with serious DPF problems. All of the tested vehicles are used on short drive cycles.

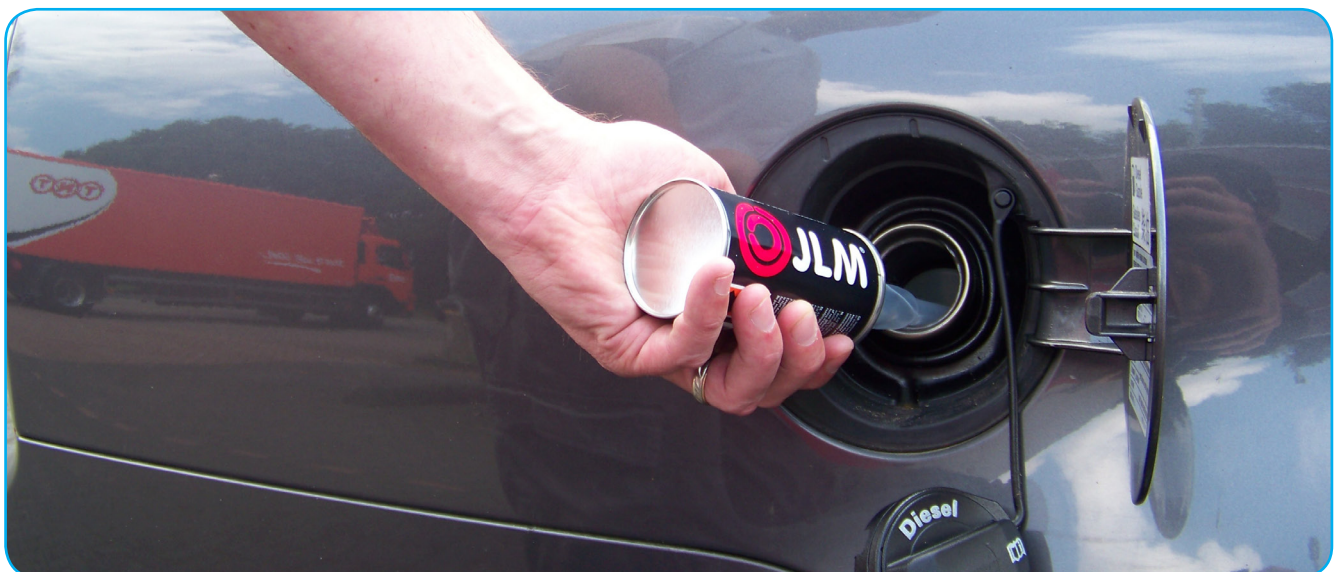
Before Treatment:

Idle 800rpm	DPF pressure sensor	4 kpa
2000rpm	DPF pressure sensor	17 kpa
4000rpm	DPF pressure sensor	47 kpa

After Treatment:

Idle 800rpm	DPF pressure sensor	0 kpa
2000rpm	DPF pressure sensor	0 kpa
4000rpm	DPF pressure sensor	0 kpa

Diagnostic note - Last regeneration 547 km.

Action
100ml of JLM DPF Cleaner added to a full tank of fuel.
Vehicle rechecked when complete tank of DPF fuel used.
